IMPORTANT INSTALLATION NOTICE

Fuel feed unit 2250543

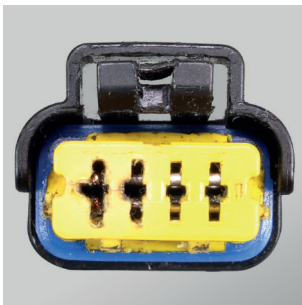
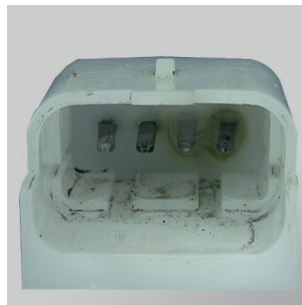
Vor dem Austausch der Kraftstofffördereinheit bitte die Steckkontakte auf Auffälligkeiten prüfen.

Sollten sie eine Verfärbung an den Kontakten, am Kunststoff oder Scheuerstellen an dem Stecker feststellen, müssen weitere Teile mit ausgetauscht werden.

Durch einen zu geringen Abstand zwischen dem Anschlussstecker, der Pumpeneinheit und der Karosserie kann es bei ungünstiger Konstellation zum Kontakt kommen. Dieser Kontakt kann Hochspannungsimpulse verursachen und in der Folge zu einem Überhitzen der Steckkontakte und zum Schmelzen des Kunststoffes führen.

Bei der Montage auf korrekte Verriegelung des Steckers achten.

Bitte verwenden Sie beim Austausch der Kraftstofffördereinheit zusätzlich folgenden Metzger Kabelreparatursatz: 2324101.

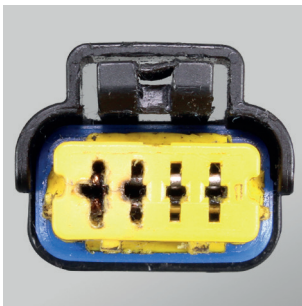
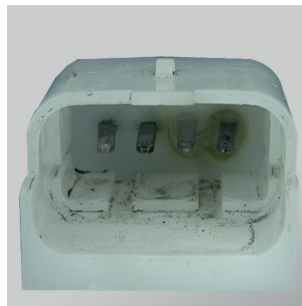
Before replacing the fuel feed unit, please check the plug contacts for abnormalities.

If you notice any coloration on the contacts, on the plastic or chafe marks on the plug, other parts must be also be replaced.

If the distance between the connecting plug, the pump unit and the car body is too small, contact may occur if the constellation is unfavourable. This contact can cause high-voltage pulses and lead to overheating of the plug contacts and melting of the plastic.

When installing, ensure that the plug is correctly locked in place.

Please also use the following Metzger cable repair kit to replace the fuel feed unit: 2324101.
